Analysis of The Technical Condition of Water Pipes in The Railway Network of JSC "Uzbek Railways"

ABSTRACT: At present, there are a lot of waterproofing pipes that make up more than half of all artificial structures located in the railway network. The technical condition is the main characteristic of the ability of the pipes to provide a normal operating regime, which is associated with the safe passage of trains at the specified speed and the continuous passage of water flow through the body of the water-conducting pipe. It is indicated that there are malfunctions in the current technical condition of artificial structures located on railways under real conditions.

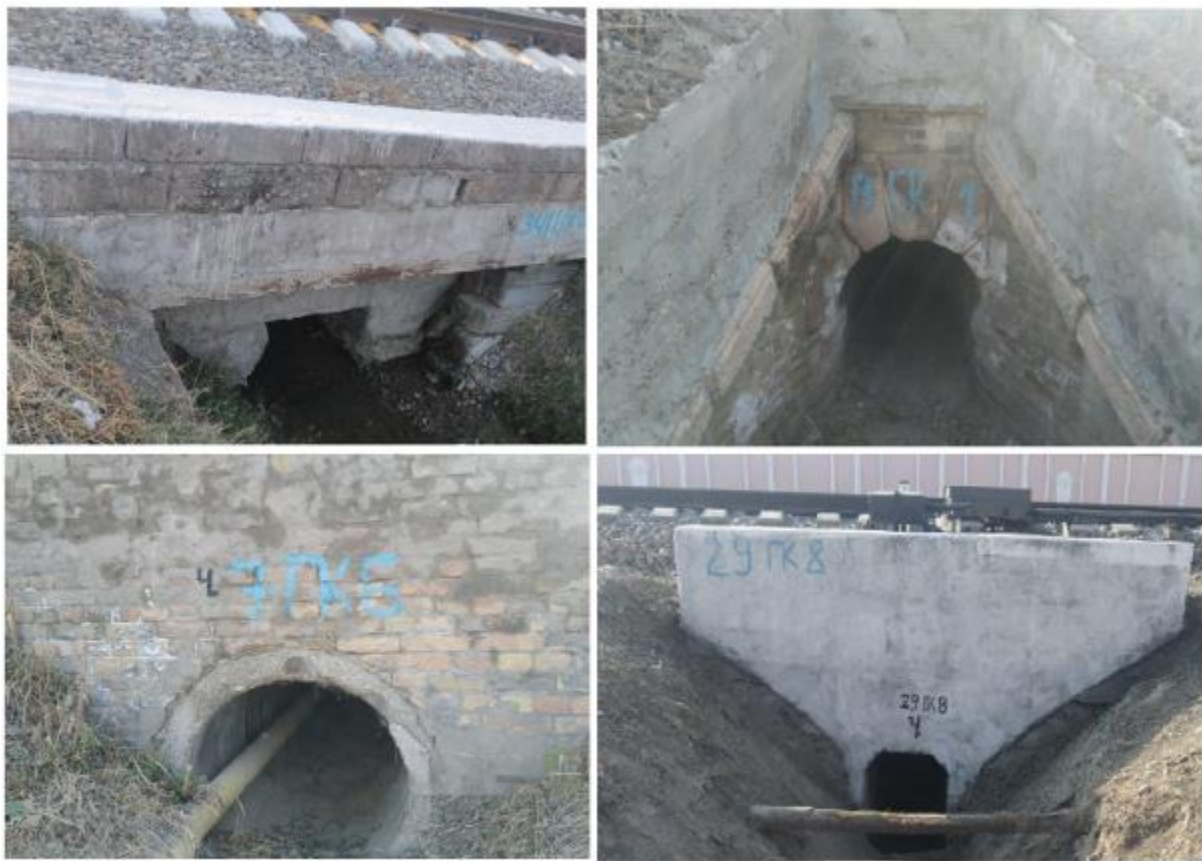
1- figure. The state of the waterproofing pipes located on the railway.

Materials and Methods. During the repair of the pipes, the inlet and outlet parts and the body along the length of the pipe are inspected. It is necessary to timely clean the pipes from sedimentary rocks, identify and eliminate the causes of their formation. It is necessary to timely clean the water-conducting pipes that pass through the railway tracks.

It is also necessary to monitor the condition of the protective coating in the aggressive environment and inside the pipe, in which cracks may appear on the pipes. Identified defects must be eliminated in a timely manner. The purpose of the article is to analyze the technical condition of artificial structures on Uzbek Railways.
